Manhole Inspection Summary

Manhole # S41UU_016MH

Insp Date: **2/15/07 1:37 PM**

Location Address: **1415 MONTPELIER ST**

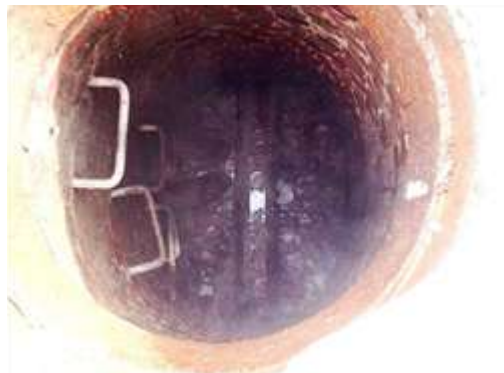
Top View

Corroded steps. Evidence of surcharge - Bench debris. Channel debris.

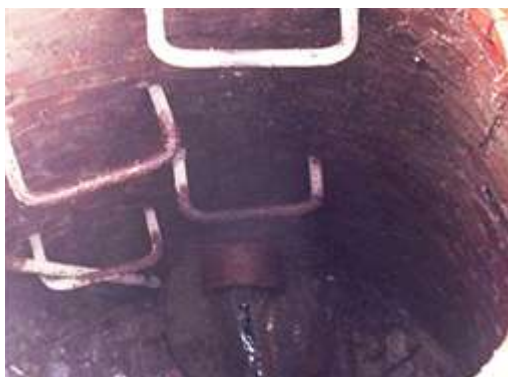
Defect

Corroded steps. Corbel root intrusion. Corbel and barrel infiltration.

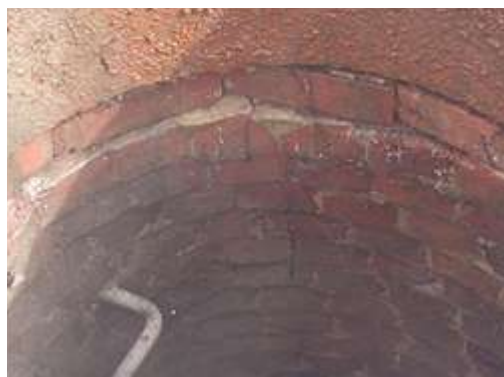
Defect

Frame leaks. Adjustment deterioration, root intrusion and infiltration. Corbel infiltration.

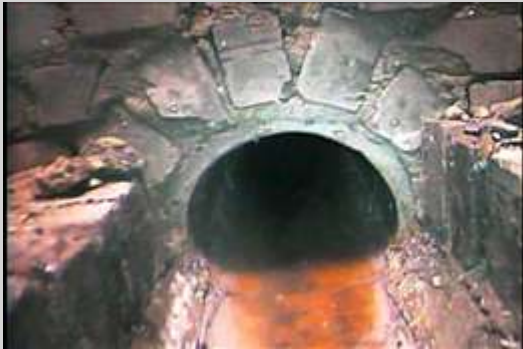
8 in. Circular Gravity Sewer Pipe Out @ 12 O'Clock

Channel deterioration. Bench and barrel deterioration.

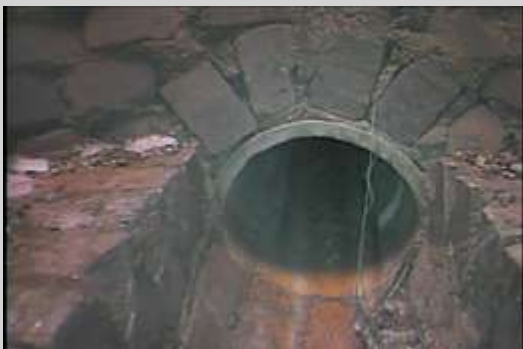
8 in. Circular Gravity Sewer Pipe In @ 6 O'Clock

Barrel root intrusion, infiltration and deterioration. Channel deterioration.

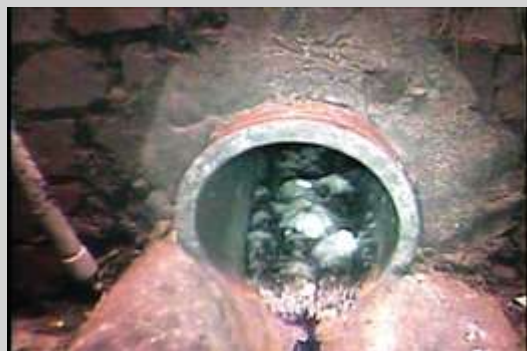
Pipe In @ 9 O'Clock

Barrel deterioration, root intrusion and infiltration.
